**Flood Control Project Maintenance
Levee Inspections**
LMA District Cover Sheet
Spring 2018 Levee Inspection Results

Reclamation District No. 0501 Ryer Island

Spring 2018 Levee Inspection Results

Waterway			Bank	Unit Miles
Unit No. 01 Steamboat Slough			Right	6.71
	Spring (March - May)	Summer (June - August)	(September - November) Fall	Winter (December - February)
Unit Maintenance Rating (Fall Only)				
Date of Inspection	3/13/2018 - 3/13/2018			
DWR Inspector	Keith Millard			
Accompanied By

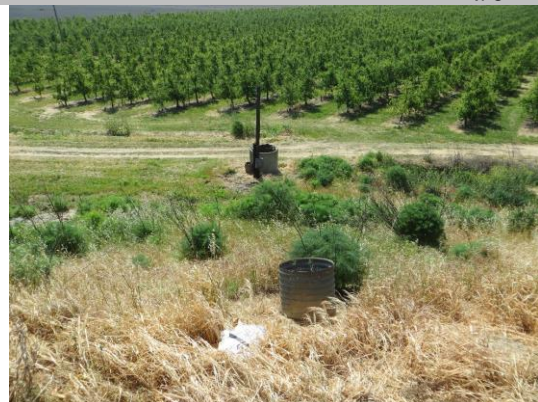
Photo 1 of 2 : UCIP_SP_2018_44728_73924.jpg

Comment Code					
Inspector Comment					
FS_ID:44728 DS_ID:21066 EP_NO: N/A Repair Type: Non-Urgent Crossing Status: Found UCIP Comments: Pipe appears abandoned and if so should be done so properly. Wooden walkway to pier in disrepair and a hazard. FIELD_STRUCT_DESC: 12-inch steel irrigation discharge pipe through the levee, 8 feet below the crown. Siphon breaker on the landside (LS) slope. Pump on a pipe structure in the stream. Concrete standpipe and distribution slide gates at the LS toe. 1.5-inch electrical conduit at the same location. [Additional Reference(s): DWR Levee Log, 2005. USACE Sacramento O&M Manual 105, April 1959, (HLM 1.5)]. FS Date: 6/7/2013

Siphon breaker in 24-inch CMP riser on LS slope. Standpipe visible at LS toe.

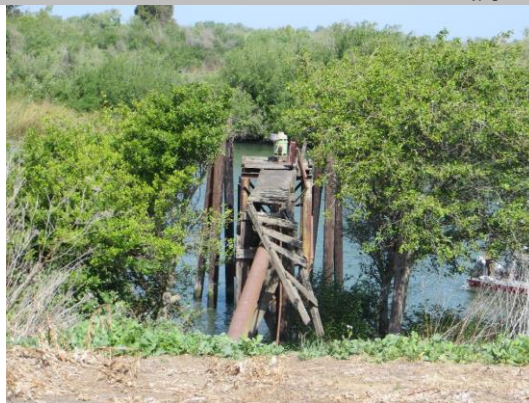
Photo 2 of 2 : UCIP_SP_2018_44728_73923.jpg

Comment Code						
Inspector Comment						
FS_ID:44728 DS_ID:21066 EP_NO: N/A Repair Type: Non-Urgent Crossing Status: Found UCIP Comments: Pipe appears abandoned and if so should be done so properly. Wooden walkway to pier in disrepair and a hazard. FIELD_STRUCT_DESC: 12-inch steel irrigation discharge pipe through the levee, 8 feet below the crown. Siphon breaker on the landside (LS) slope. Pump on a pipe structure in the stream. Concrete standpipe and distribution slide gates at the LS toe. 1.5-inch electrical conduit at the same location. [Additional Reference(s): DWR Levee Log, 2005. USACE Sacramento O&M Manual 105, April 1959, (HLM 1.5)]. FS Date: 6/7/2013

Pump on wooden pier off WS toe.

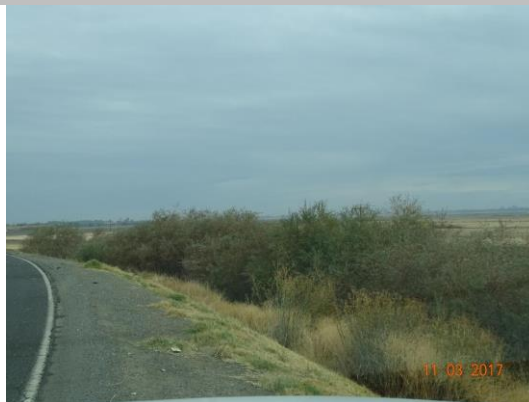
Photo 1 of 1 : SP_2018_RD0501_171_28_20180305_00001.jpg

LM Start	1.48	Rating **	M	Issue No.	28
LM End	1.48	Issue Type +	Ma	Location *	LS
Category	Earthen Levee			GPS Latitude/Longitude	
				Start	End
Item	Trim / Thin Trees			38.244293 °	38.244293 °
				-121.657843 °	-121.657843 °
DWR ID	DWR_RD0501_03_f_2017_28				
Comment Code					
T2 : Thin trees to allow visibility of the ground and room to flood fight.					
Inspector Comment					
Trim/thin willows to allow inspection and access to landside slope and toe.

Trim/thin willows to allow inspection and access to landside slope and toe.

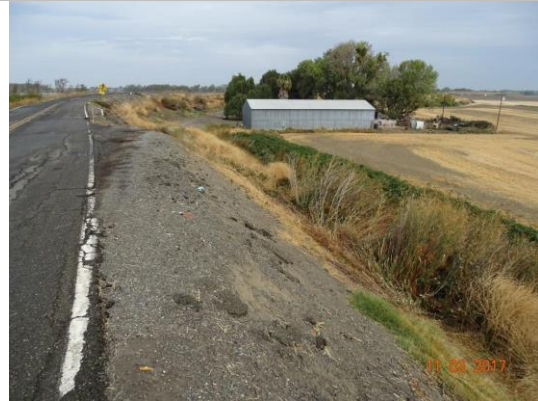
Photo 1 of 1 : SP_2018_RD0501_171_29_20180305_00002.jpg

LM Start	1.56	Rating **	M	Issue No.	29
LM End	1.56	Issue Type +	Ma	Location *	LS
Category	Earthen Levee			GPS Latitude/Longitude	
				Start	End
Item	Vegetation			38.245445 °	38.245445 °
				-121.658035 °	-121.658035 °
DWR ID	DWR_RD0501_03_f_2017_29				
Comment Code					
V2 : Remove the wild growth other than native grasses from the levee slopes.					
Inspector Comment					
Remove berry vines at landside toe to allow inspection and access.

Remove berry vines at landside toe to allow inspection and access.

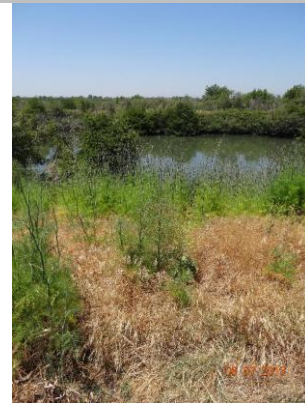
Photo 1 of 2 : UCIP_SP_2018_43503_33410.jpg

Comment Code						
Inspector Comment						
FS_ID:43503 DS_ID:21068 EP_NO: N/A Repair Type: Non-Urgent Crossing Status: Found UCIP Comments: Authorized or Unauthorized? Need permit authorizing work. Dense vegetation limits the inspector's visibility to identify signs of pipe failure (leaks) through the slope on both waterward and landward side. Recommend removing vegetation along pipe alignment to conduct proper inspection of structure and appurtenances. FIELD_STRUCT_DESC: 10-inch steel irrigation discharge pipe through the levee, 6.3 feet below the crown. Pump, gate valve, and switch box on the waterside (WS) slope. [Additional Reference(s): DWR Levee Log, 2005. USACE Sacramento O&M Manual 105, April 1959, (HLM 2.0), reported as 3.8 feet below the crown]. FS Date: 6/7/2013

Overview of waterward side. Pipe is completely obstructed by dense vegetation.

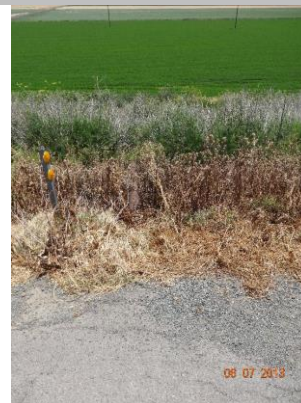
Photo 2 of 2 : UCIP_SP_2018_43503_33411.jpg

Comment Code						
Inspector Comment						
FS_ID:43503 DS_ID:21068 EP_NO: N/A Repair Type: Non-Urgent Crossing Status: Found UCIP Comments: Authorized or Unauthorized? Need permit authorizing work. Dense vegetation limits the inspector's visibility to identify signs of pipe failure (leaks) through the slope on both waterward and landward side. Recommend removing vegetation along pipe alignment to conduct proper inspection of structure and appurtenances. FIELD_STRUCT_DESC: 10-inch steel irrigation discharge pipe through the levee, 6.3 feet below the crown. Pump, gate valve, and switch box on the waterside (WS) slope. [Additional Reference(s): DWR Levee Log, 2005. USACE Sacramento O&M Manual 105, April 1959, (HLM 2.0), reported as 3.8 feet below the crown]. FS Date: 6/7/2013

Overview of landward side. Pipe is visible however dense vegetation limits proper inspection.

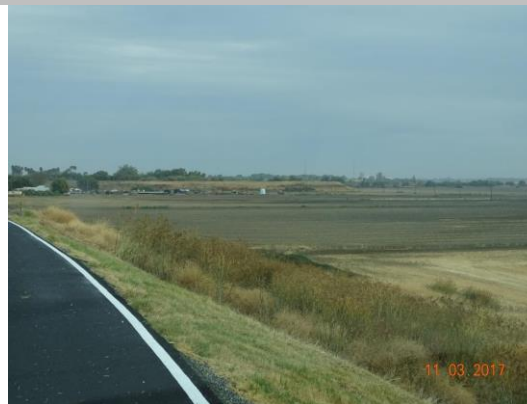
Photo 1 of 1 : SP_2018_RD0501_171_30_20180305_00003.jpg

LM Start	1.89	Rating **	M	Issue No.	30
LM End	1.89	Issue Type +	Ma	Location *	LS
Category	Earthen Levee			GPS Latitude/Longitude	
				Start	End
Item	Vegetation			38.249428 °	38.249428 °
				-121.656310 °	-121.656310 °
DWR ID	DWR_RD0501_03_f_2017_30				
Comment Code					
V2 : Remove the wild growth other than native grasses from the levee slopes.					
Inspector Comment					
Remove/manage landside vegetation and berry vines to allow inspection and access to slope and toe.

Remove/manage landside vegetation and berry vines to allow inspection and access to slope and toe.

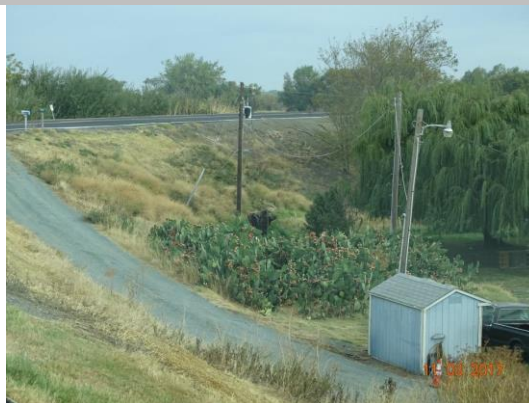
Photo 1 of 2 : SP_2018_RD0501_171_31_20180305_00004.jpg

LM Start	2.20	Rating **	M	Issue No.	31
LM End	2.20	Issue Type +	En	Location *	LS
Category	Earthen Levee			GPS Latitude/Longitude	
				Start	End
Item	Vegetation			38.253885 °	38.253885 °
				-121.655353 °	-121.655353 °
DWR ID	DWR_RD0501_03_f_2017_31				
Comment Code					
V6 : Landscaping					
Inspector Comment					
Remove large cactus at landside toe to allow inspection and access.

Remove large cactus at landside toe to allow inspection and access.

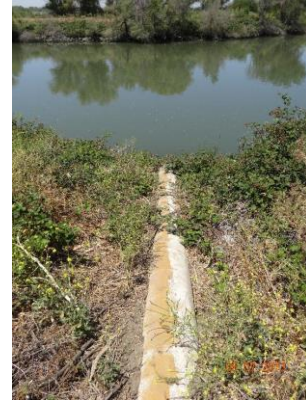
Photo 3 of 3 : UCIP_SP_2018_18945_31608.jpg

LM Start	2.52	Rating **	M	Issue No.	47 (cont)
LM End	2.52	Issue Type +	En	Location *	
Category	Supplemental			GPS Latitude/Longitude	
				Start	End
Item	DWR UCIP Field Study			38.256255 °	38.256255 °
				-121.651551 °	-121.651551 °
DWR ID					
Comment Code					
Inspector Comment					
FS_ID:18945 DS_ID:21047 EP_NO: N/A Repair Type: Non-Urgent Crossing Status: Found UCIP Comments: Need to determine owner of structure. Recommend removing vegetation along pipe alignment to conduct proper inspection of structure and appurtenances. FIELD_STRUCT_DESC: 16-inch steel irrigation siphon pipe through the levee, 3.3 feet below the crown. Gate valve and switch box on the landside (LS) slope. Pipe exposed on both slopes. Riprap on the waterside (WS). [Additional Reference(s): DWR Levee Log, 2005. USACE Sacramento O&M Manual 105, April 1959, (HLM 2.7)]. FS Date: 6/7/2013

Exposed section of pipe located on waterward side.

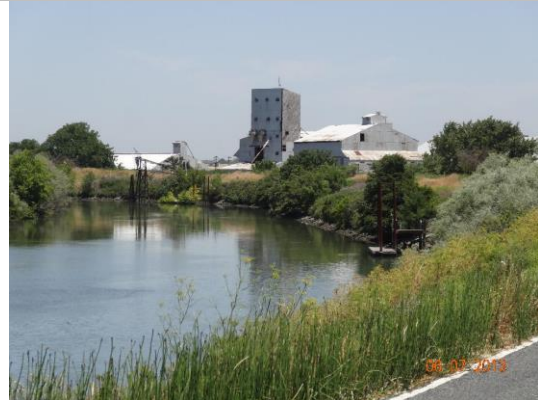
Photo 1 of 3 : UCIP_SP_2018_32538_58994.jpg

Comment Code						
Inspector Comment						
FS_ID:32538 DS_ID:21048 EP_NO: N/A Repair Type: Non-Urgent Crossing Status: Found UCIP Comments: Dense vegetation limits the inspector's visibility to identify signs of pipe failure (leaks) through the waterward slope. Recommend removing vegetation along pipe alignment to conduct proper inspection of structure and appurtenances. Need to find owner of crossing and determine if permit number is available. FIELD_STRUCT_DESC: 12-inch steel irrigation discharge pipe through the levee, 5 feet below the crown. Pump on a pile structure in the stream. Service pole on the landside (LS) slope. Concrete standpipe at the LS toe. [Additional Reference(s): DWR Levee Log, 2005. USACE Sacramento O&M Manual 105, April 1959, (HLM 3.8)]. FS Date: 6/7/2013

Photo taken downstream of structure.

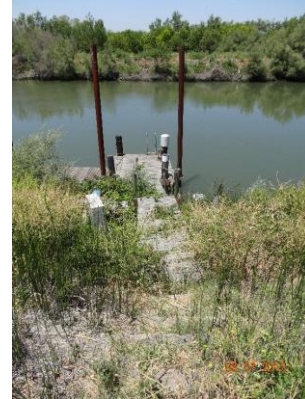
Photo 2 of 3 : UCIP_SP_2018_32538_58999.jpg

Comment Code						
Inspector Comment						
FS_ID:32538						
DS_ID:21048						
EP_NO: N/A						
Repair Type: Non-Urgent						
Crossing Status: Found						
UCIP Comments: Dense vegetation limits the inspector's visibility to identify signs of pipe failure (leaks) through the waterward slope. Recommend removing vegetation along pipe alignment to conduct proper inspection of structure and appurtenances. Need to find owner of crossing and determine if permit number is available.						
FIELD_STRUCT_DESC: 12-inch steel irrigation discharge pipe through the levee, 5 feet below the crown. Pump on a pile structure in the stream. Service pole on the landside (LS) slope. Concrete standpipe at the LS toe. [Additional Reference(s): DWR Levee Log, 2005. USACE Sacramento O&M Manual 105, April 1959, (HLM 3.8)].						
FS Date: 6/7/2013

View of waterward side. Dense vegetation throughout waterward side. Walkway visible and support piles.

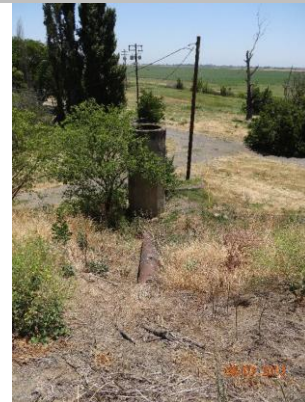
Photo 3 of 3 : UCIP_SP_2018_32538_58998.jpg

View of landward side--section of pipe exposed and Standpipe.

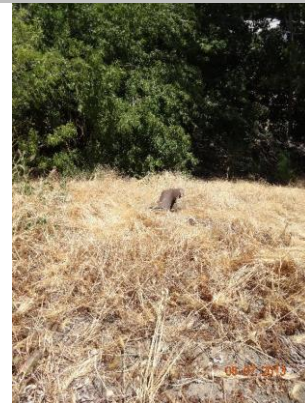
Photo 1 of 3 : UCIP_SP_2018_46768_30382.jpg

Comment Code					
Inspector Comment					
FS_ID:46768 DS_ID:21049 EP_NO: 1557 Repair Type: Non-Urgent Crossing Status: Found UCIP Comments: Crossing appears abandoned--wooden platform structure appears to be abandoned on waterward side. Small hole underneath pipe on landward side--unable to determine cause (rodent/pipe leak) Need to find owner of crossing to determine status. Recommend removing vegetation along pipe alignment to conduct proper inspection of structure and appurtenances. FIELD_STRUCT_DESC: *ABANDONED* 6-inch irrigation discharge pipe of an unknown material through the levee, 2.5 feet below the crown. Pump in a pump house on the waterside (WS) slope. (Plans for the construction of two irrigation pumping plants, about 500 feet apart, and 6-inch discharge pipes through the levee authorized under Permit No. 1557, 1951 - Poultry Producers of Central California). [Additional Reference(s): DWR Levee Log, 2005. USACE Sacramento O&M Manual 105, April 1959, (HLM 3.9)]. FS Date: 6/7/2013

View of landward side showing a small section of pipe exposed.

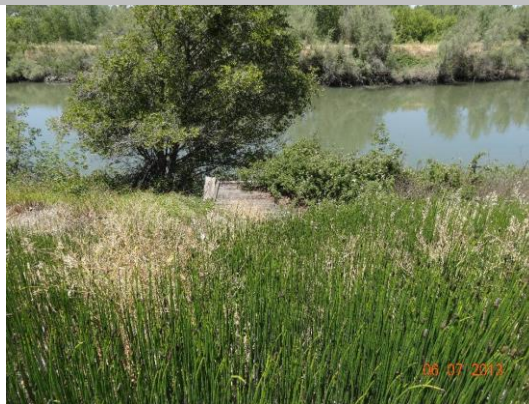
Photo 3 of 3 : UCIP_SP_2018_46768_30380.jpg

Comment Code						
Inspector Comment						
FS_ID:46768 DS_ID:21049 EP_NO: 1557 Repair Type: Non-Urgent Crossing Status: Found UCIP Comments: Crossing appears abandoned--wooden platform structure appears to be abandoned on waterward side. Small hole underneath pipe on landward side--unable to determine cause (rodent/pipe leak) Need to find owner of crossing to determine status. Recommend removing vegetation along pipe alignment to conduct proper inspection of structure and appurtenances. FIELD_STRUCT_DESC: *ABANDONED* 6-inch irrigation discharge pipe of an unknown material through the levee, 2.5 feet below the crown. Pump in a pump house on the waterside (WS) slope. (Plans for the construction of two irrigation pumping plants, about 500 feet apart, and 6-inch discharge pipes through the levee authorized under Permit No. 1557, 1951 - Poultry Producers of Central California). [Additional Reference(s): DWR Levee Log, 2005. USACE Sacramento O&M Manual 105, April 1959, (HLM 3.9)]. FS Date: 6/7/2013

Overview of waterward side with limited access to structure.

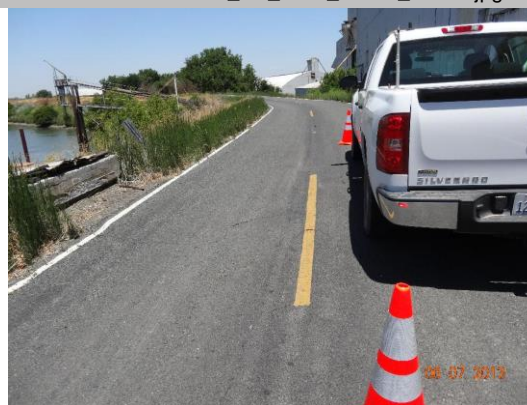
Photo 1 of 3 : UCIP_SP_2018_32540_59007.jpg

Comment Code					
Inspector Comment					
FS_ID:32540 DS_ID:21050 EP_NO: N/A Repair Type: Non-Urgent Crossing Status: Found UCIP Comments: Unable to properly inspect structure--limited access. Also unable to determine if structure is still in use. Levee logs indicate this crossing is abandoned. If structre is no longer used-how to prevent water from flowing through levee during flood season. If structure no longer in use owner will need to coordinate with CVFPB. FIELD_STRUCT_DESC: *ABANDONED* 66-inch by 66-inch reinforced concrete gravity drainage tunnel through the levee, 6.5 feet below the crown. [Additional Reference(s): DWR Levee Log, 2005]. FS Date: 6/7/2013

View of narrow levee crown.

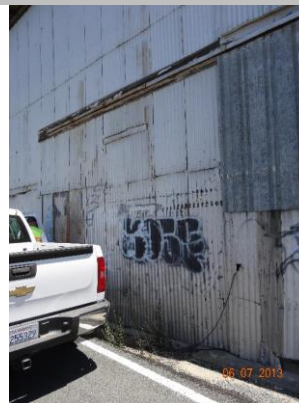
Photo 2 of 3 : UCIP_SP_2018_32540_59006.jpg

Comment Code						
Inspector Comment						
FS_ID:32540 DS_ID:21050 EP_NO: N/A Repair Type: Non-Urgent Crossing Status: Found UCIP Comments: Unable to properly inspect structure--limited access. Also unable to determine if structure is still in use. Levee logs indicate this crossing is abandoned. If structre is no longer used-how to prevent water from flowing through levee during flood season. If structure no longer in use owner will need to coordinate with CVFPB. FIELD_STRUCT_DESC: *ABANDONED* 66-inch by 66-inch reinforced concrete gravity drainage tunnel through the levee, 6.5 feet below the crown. [Additional Reference(s): DWR Levee Log, 2005]. FS Date: 6/7/2013

View of large building structure located on landward side.

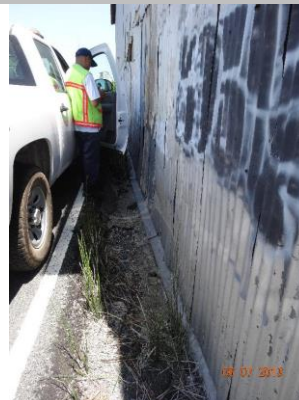
Photo 3 of 3 : UCIP_SP_2018_32540_59003.jpg

View of structure on landward side.

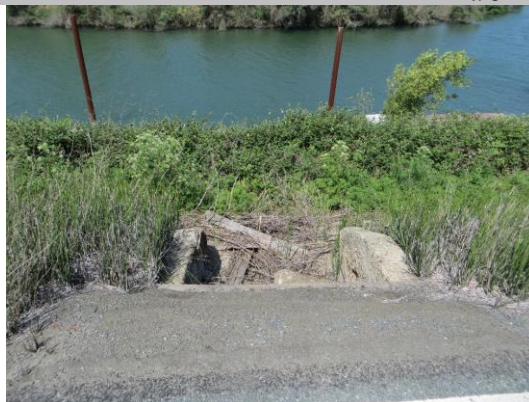
Photo 2 of 3 : UCIP_SP_2018_50023_73941.jpg

Comment Code					
Inspector Comment					
FS_ID:50023 DS_ID:21051 EP_NO: N/A Repair Type: Urgent Crossing Status: Found UCIP Comments: 8/22/2016 Unable to locate due to high traffic area and narrow levee crown. Assume condition is same as previous inspection. CVFPB should review this crossing to determine if WS needs to be capped off for flood season. (DWR UCIP - omagana)4/23/2015 Concrete deteriorating. Pipe open on both ends. Appears abandoned and if so should be done so properly. (DWR UCIP - omagana) FIELD_STRUCT_DESC: *ABANDONED* 66-inch by 72-inch reinforced concrete drainage tunnel through the levee, 2.5 feet below the crown. [Additional Reference(s): DWR Levee Log, 2005]. FS Date: 8/22/2016

Concrete tunnel and wingwalls visible on WS slope.

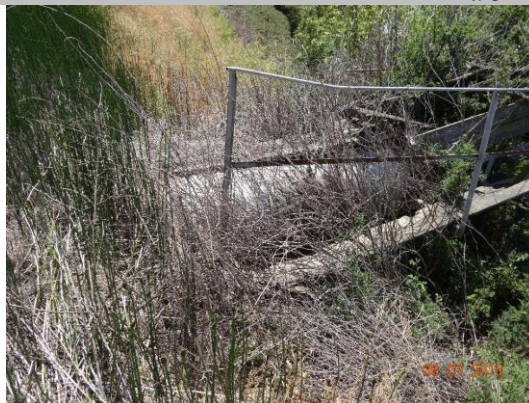
Photo 1 of 3 : UCIP_SP_2018_19662_33420.jpg

Comment Code					
Inspector Comment					
FS_ID:19662 DS_ID:21052 EP_NO: N/A Repair Type: Non-Urgent Crossing Status: Found UCIP Comments: Need to abandon structure properly--contact owner. Also if crossing is still in use--recommend removing vegetation along pipe alignment to conduct proper inspection of structure and appurtenances. FIELD_STRUCT_DESC: 36-inch grain conveyor culvert of an unknown material through the levee, 5 feet below the crown. Grain loading auger sleeved through the culvert. Grain loading system on a platform in the channel. (Plans for installing a 36-inch culvert to be used for housing a 14-inch screw-type bulk grain conveyor through the levee authorized under Permit No. 1503, 1959 - Bay Cities Transportation Company). [Additional Reference(s): DWR Levee Log, 2005. USACE Sacramento O&M Manual 105, April 1950, (HLM 4.0)]. FS Date: 6/7/2013

View of waterward side. Pipe visible through dense vegetation.

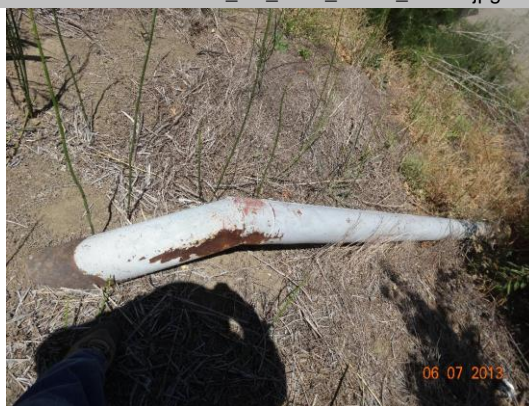
Photo 3 of 3 : UCIP_SP_2018_43524_33423.jpg

Comment Code					
Inspector Comment					
FS_ID:43524 DS_ID:21053 EP_NO: N/A Repair Type: Non-Urgent Crossing Status: Found UCIP Comments: Dense vegetation limits the inspector's visibility to identify signs of pipe failure (leaks) through the waterward slope. Recommend removing vegetation along pipe alignment to conduct proper inspection of structure and appurtenances. FIELD_STRUCT_DESC: 6-inch irrigation discharge pipe of an unknown material through the levee, 2.5 feet below the crown. Pump in a pump house on the waterside (WS) slope. (Plans for the construction of two irrigation pumping plants, about 500 feet apart, and 6-inch discharge pipes through the levee authorized under Permit No. 1557, 1951 - Poultry Producers of Central California). [Additional Reference(s): DWR Levee Log, 2005. USACE Sacramento O&M Manual 105, April 1959, (HLM 4.0)]. FS Date: 6/7/2013

Close up of pipe along landward side.

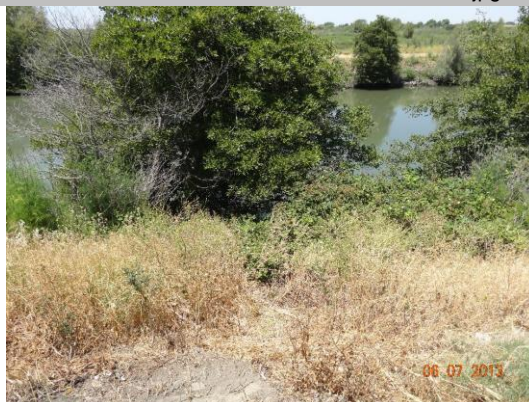
Photo 2 of 3 : UCIP_SP_2018_44876_33428.jpg

Item	DWR UCIP Field Study		38.275862 °	38.275862 °								
			-121.638709 °	-121.638709 °								
DWR ID												
Comment Code												
Inspector Comment												
FS_ID:44876 DS_ID:21069 EP_NO: N/A Repair Type: Non-Urgent Crossing Status: Found UCIP Comments: Damage to levee shoulder. Crossing appears to be still be in use--need to contact owner to inform about maintenance issues. Dense vegetation limits the inspector's visibility to identify signs of pipe failure (leaks) along the waterward and landward slope. Recommend removing vegetation along pipe alignment to conduct proper inspection of structure and appurtenances. FIELD_STRUCT_DESC: 18-inch steel irrigation discharge pipe sleeved through a 24-inch pipe of an unknown material through the levee, 6.5 feet below the crown. Cutoff wall around the pipe at the waterside (WS) shoulder. Siphon breaker on the apex of the pipe at the landside (LS) shoulder. Pump in a pump house on the LS slope. (Plans for an 18-inch steel pipe to be sleeved through the 24-inch pipe with annular space grouted authorized under Permit No. 2496, 1957 - Reclamation District No. 501 [RD0501]). [Additional Reference(s): DWR Levee Log, 2005. USACE Sacramento O&M Manual 105, April 1959, (HLM 4.6)]. FS Date: 6/7/2013

View of waterward slope. Dense vegetation along slope.

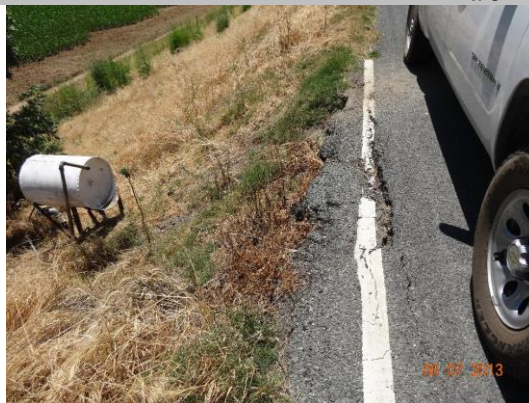
Photo 3 of 3 : UCIP_SP_2018_44876_33430.jpg

Comment Code						
Inspector Comment						
FS_ID:44876 DS_ID:21069 EP_NO: N/A Repair Type: Non-Urgent Crossing Status: Found UCIP Comments: Damage to levee shoulder. Crossing appears to be still be in use--need to contact owner to inform about maintenance issues. Dense vegetation limits the inspector's visibility to identify signs of pipe failure (leaks) along the waterward and landward slope. Recommend removing vegetation along pipe alignment to conduct proper inspection of structure and appurtenances. FIELD_STRUCT_DESC: 18-inch steel irrigation discharge pipe sleeved through a 24-inch pipe of an unknown material through the levee, 6.5 feet below the crown. Cutoff wall around the pipe at the waterside (WS) shoulder. Siphon breaker on the apex of the pipe at the landside (LS) shoulder. Pump in a pump house on the LS slope. (Plans for an 18-inch steel pipe to be sleeved through the 24-inch pipe with annular space grouted authorized under Permit No. 2496, 1957 - Reclamation District No. 501 [RD0501]). [Additional Reference(s): DWR Levee Log, 2005. USACE Sacramento O&M Manual 105, April 1959, (HLM 4.6)]. FS Date: 6/7/2013

View of landward side. Dry vegetation covers landward slope. Pump system located on landward slope.

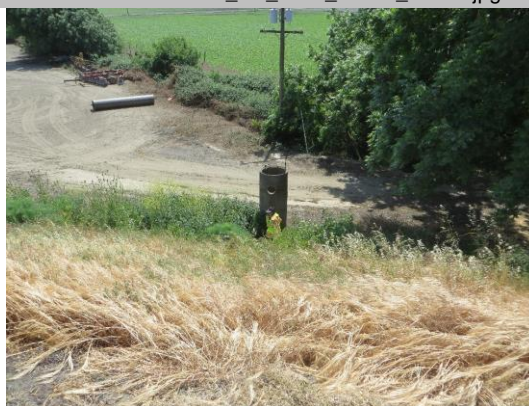
Photo 1 of 2 : UCIP_SP_2018_44746_73944.jpg

LM Start	4.31	Rating **	M	Issue No.	55
LM End	4.31	Issue Type +	En	Location *	
Category	Supplemental			GPS Latitude/Longitude	
				Start	End
Item	DWR UCIP Field Study			38.275955 °	38.275955 °
				-121.638626 °	-121.638626 °
DWR ID					
Comment Code					
Inspector Comment					
FS_ID:44746					
DS_ID:21107					
EP_NO: N/A					
Repair Type: Non-Urgent					
Crossing Status: Indicator Found					
UCIP Comments: Need to verify type of abandonment.					
FIELD_STRUCT_DESC: *ABANDONED* 10-inch irrigation discharge pipe of an unknown material through the levee, 4.8 feet below the crown. 34-inch concrete standpipe on the landside (LS) toe. 10-inch hole in the standpipe where the abandoned pipe once connected.					
[Additional Reference(s): USACE Sacramento O&M Manual 105, April 1959, (HLM 4.6)].					
FS Date: 4/23/2015

34-inch diameter concrete standpipe at LS toe.

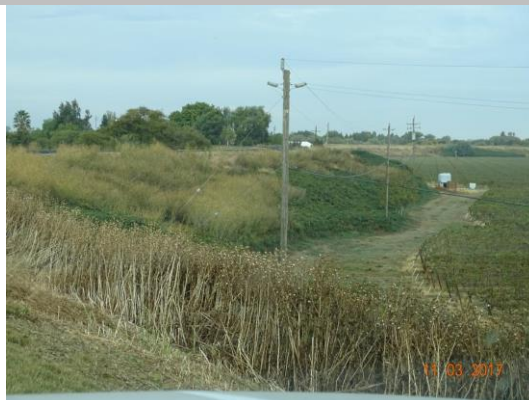
Photo 1 of 1 : SP_2018_RD0501_171_34_20180305_00005.jpg

LM Start	4.47	Rating **	M	Issue No.	34
LM End	4.80	Issue Type +	Ma	Location *	LS
Category	Earthen Levee			GPS Latitude/Longitude	
				Start	End
Item	Vegetation			38.277918 °	38.281507 °
				-121.637670 °	-121.641595 °
DWR ID	DWR_RD0501_03_f_2017_34				
Comment Code					
V2 : Remove the wild growth other than native grasses from the levee slopes.					
Inspector Comment					
Remove berry vines on landside slope and toe to allow inspection and access.

Remove berry vines on landside slope and toe to allow inspection and access.

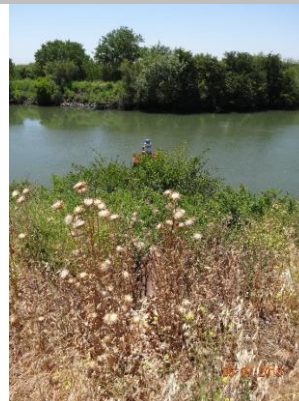
Photo 1 of 2 : UCIP_SP_2018_32541_59008.jpg

Comment Code					
Inspector Comment					
FS_ID:32541 DS_ID:21071 EP_NO: N/A Repair Type: Non-Urgent Crossing Status: Found UCIP Comments: --Contact owner--Dense vegetation limits the inspector's visibility to identify signs of pipe failure (leaks) along the waterward and landward slopes. Recommend removing vegetation along pipe alignment to conduct proper inspection of structure and appurtances. Walkway and siphon breaker not found. FIELD_STRUCT_DESC: 12-inch reinforced concrete irrigation discharge pipe through the levee, 2.5 feet below the crown. Cutoff wall around the pipe at the center of the levee. Siphon breaker at the apex of the pipe on the shoulder. Pump on a pile structure in the stream. Walkway access to pump. [Additional Reference(s): DWR Levee Log, 2005. USACE Sacramento O&M Manual 105, April 1959, (HLM 5.1)]. FS Date: 6/7/2013

View of waterward side. Pump located on pile structure in stream.

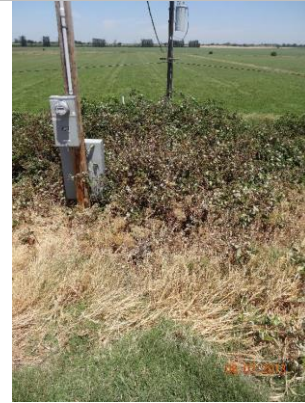
Photo 2 of 2 : UCIP_SP_2018_32541_59009.jpg

Comment Code						
Inspector Comment						
FS_ID:32541 DS_ID:21071 EP_NO: N/A Repair Type: Non-Urgent Crossing Status: Found UCIP Comments: --Contact owner--Dense vegetation limits the inspector's visibility to identify signs of pipe failure (leaks) along the waterward and landward slopes. Recommend removing vegetation along pipe alignment to conduct proper inspection of structure and appurtances. Walkway and siphon breaker not found. FIELD_STRUCT_DESC: 12-inch reinforced concrete irrigation discharge pipe through the levee, 2.5 feet below the crown. Cutoff wall around the pipe at the center of the levee. Siphon breaker at the apex of the pipe on the shoulder. Pump on a pile structure in the stream. Walkway access to pump. [Additional Reference(s): DWR Levee Log, 2005. USACE Sacramento O&M Manual 105, April 1959, (HLM 5.1)]. FS Date: 6/7/2013

View of landward side. Power source and control box on landward side.

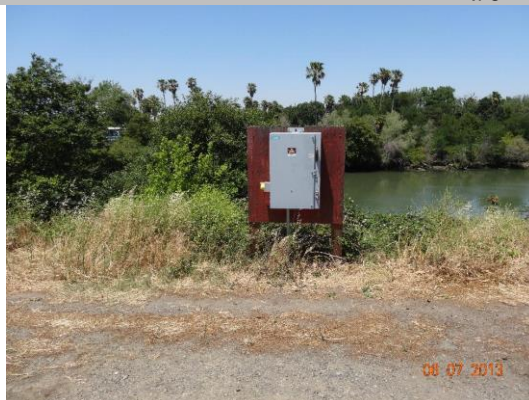
Photo 1 of 3 : UCIP_SP_2018_19666_33435.jpg

Comment Code						
Inspector Comment						
FS_ID:19666 DS_ID:21054 EP_NO: N/A Repair Type: Non-Urgent Crossing Status: Found UCIP Comments: Need to find owner and permit number authorizing work. Dense vegetation limits the inspector's visibility to identify signs of pipe failure (leaks) along the waterward and landward slopes. Recommend removing vegetation along pipe alignment to conduct proper inspection of structure and appurtenances. FIELD_STRUCT_DESC: 12-inch irrigation discharge pipe of an unknown material through the levee, 3 feet below the crown. Pump on a pile structure in the stream. [Additional Reference(s): DWR Levee Log, 2005]. FS Date: 6/7/2013

Overview of waterward side. Control box located near levee crown.

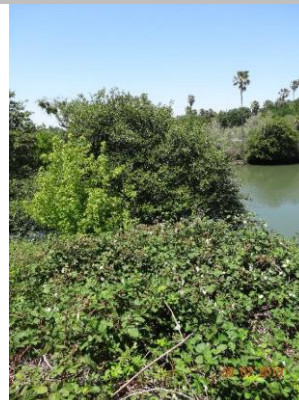
Photo 2 of 3 : UCIP_SP_2018_19666_33434.jpg

Structure visible through the dense vegetation. Limited access unable to inspect.

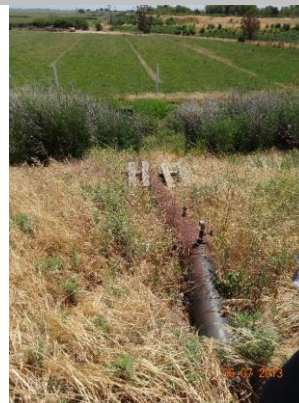
Photo 3 of 3 : UCIP_SP_2018_19666_33433.jpg

Comment Code						
Inspector Comment						
FS_ID:19666 DS_ID:21054 EP_NO: N/A Repair Type: Non-Urgent Crossing Status: Found UCIP Comments: Need to find owner and permit number authorizing work. Dense vegetation limits the inspector's visibility to identify signs of pipe failure (leaks) along the waterward and landward slopes. Recommend removing vegetation along pipe alignment to conduct proper inspection of structure and appurtenances. FIELD_STRUCT_DESC: 12-inch irrigation discharge pipe of an unknown material through the levee, 3 feet below the crown. Pump on a pile structure in the stream. [Additional Reference(s): DWR Levee Log, 2005]. FS Date: 6/7/2013

View of pipe on landward side. Dry vegetation covers landward slope.

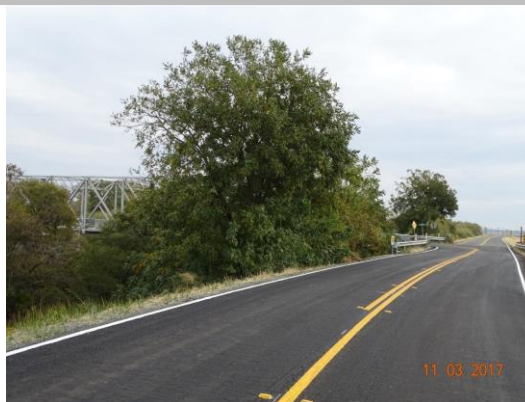
Photo 1 of 1 : SP_2018_RD0501_171_40_20180305_00008.jpg

LM Start	6.14	Rating **	M	Issue No.	40
LM End	6.14	Issue Type +	Ma	Location *	WS
Category	Earthen Levee			GPS Latitude/Longitude	
				Start	End
Item	Trim / Thin Trees			38.291563 °	38.291563 °
				-121.632068 °	-121.632068 °
DWR ID	DWR_RD0501_03_f_2017_40				
Comment Code					
T1 : Trim trees to at least five feet above ground level.					
Inspector Comment

Trim/thin trees on waterside to allow inspection and access.

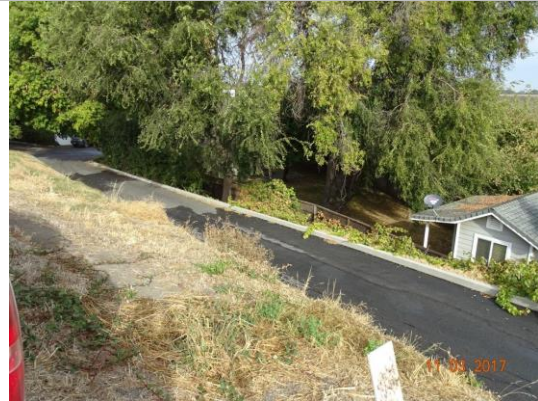
Photo 1 of 1 : SP_2018_RD0501_171_41_20180305_00009.jpg

LM Start	6.17	Rating **	M	Issue No.	41
LM End	6.17	Issue Type +	En	Location *	WS
Category	Earthen Levee			GPS Latitude/Longitude	
				Start	End
Item	Vegetation			38.291460 °	38.291460 °
				-121.631455 °	-121.631455 °
DWR ID	DWR_RD0501_03_f_2017_41				
Comment Code					
V6 : Landscaping					
Inspector Comment					
Trim/thin trees and landscaping to allow inspection and access to levee slope and toe.

Trim/thin trees and landscaping to allow inspection and access to levee slope and toe.

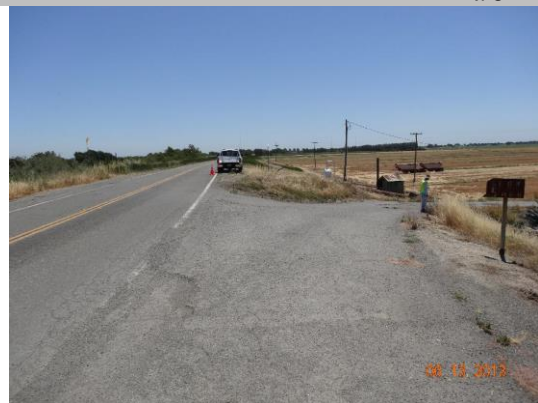
Photo 1 of 3 : UCIP_SP_2018_32542_59022.jpg

Comment Code						
Inspector Comment						
FS_ID:32542 DS_ID:21059 EP_NO: N/A Repair Type: Non-Urgent Crossing Status: Found UCIP Comments: Need to determine status of crossing. Horizontal and vertical cracks present on stand pipe located on landward side. Dense vegetation limits the inspector's visibility to identify signs of pipe failure (leaks) along the waterward slope. Recommend removing vegetation along pipe alignment to conduct proper inspection of structure and appurtenances. FIELD_STRUCT_DESC: 12-inch steel irrigation discharge pipe through the levee, 6 feet below the crown. 2-inch electrical conduit of an unknown material through the levee, at an unknown depth. Pump and gate valve on the waterside (WS) slope. Pipe exposed on the landside (LS). [Additional Reference(s): DWR Levee Log, 2005. USACE Sacramento O&M Manual 105, April 1959, (HLM 6.9)]. FS Date: 6/13/2013

Overview of levee crown at crossing.

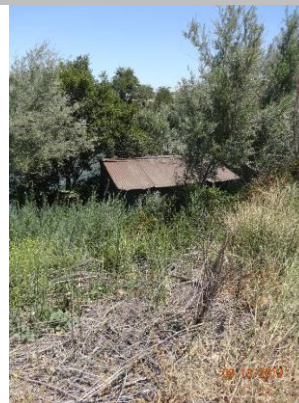
Photo 2 of 3 : UCIP_SP_2018_32542_59023.jpg

Comment Code						
Inspector Comment						
FS_ID:32542						
DS_ID:21059						
EP_NO: N/A						
Repair Type: Non-Urgent						
Crossing Status: Found						
UCIP Comments: Need to determine status of crossing. Horizontal and vertical cracks present on stand pipe located on landward side. Dense vegetation limits the inspector's visibility to identify signs of pipe failure (leaks) along the waterward slope. Recommend removing vegetation along pipe alignment to conduct proper inspection of structure and appurtenances.						
FIELD_STRUCT_DESC: 12-inch steel irrigation discharge pipe through the levee, 6 feet below the crown. 2-inch electrical conduit of an unknown material through the levee, at an unknown depth. Pump and gate valve on the waterside (WS) slope. Pipe exposed on the landside (LS). [Additional Reference(s): DWR Levee Log, 2005. USACE Sacramento O&M Manual 105, April 1959, (HLM 6.9)].

View of waterward side. Dense vegetation along levee slope.

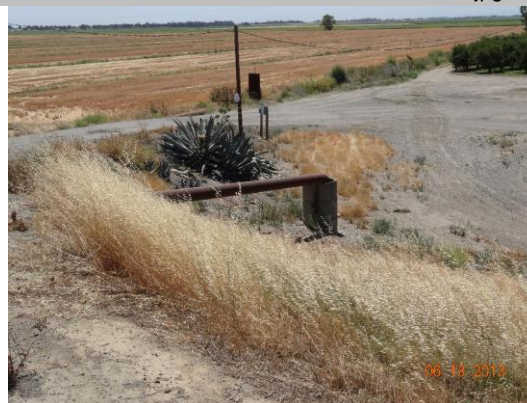
Photo 3 of 3 : UCIP_SP_2018_32542_59021.jpg

View of landward side. Pipe goes through levee and into concrete standpipe.

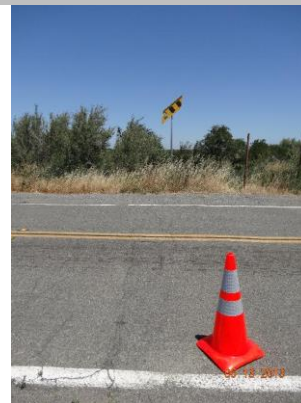
Photo 1 of 3 : UCIP_SP_2018_42118_72902.jpg

LM Start	6.40	Rating **	M	Issue No.	60
LM End	6.40	Issue Type +	En	Location *	
Category	Supplemental			GPS Latitude/Longitude	
				Start	End
Item	DWR UCIP Field Study			38.290356 °	38.290356 °
				-121.627488 °	-121.627488 °
DWR ID					
Comment Code					
Inspector Comment					
FS_ID:42118					
DS_ID:24054					
EP_NO: N/A					
Repair Type: Non-Urgent					
Crossing Status: Indicator Found					
UCIP Comments: Need to determine encroachment number issued for pipe installation.					
FIELD_STRUCT_DESC: Natural gas pipeline of an unknown size or material through the levee at an angle, at an unknown depth. Markers visible on each side. [Additional Reference(s): DWR Levee Log, 2005. USACE Sacramento O&M Manual 105, April 1959, (HLM 6.9)].					
FS Date: 6/13/2013

Markers visible on waterward side.

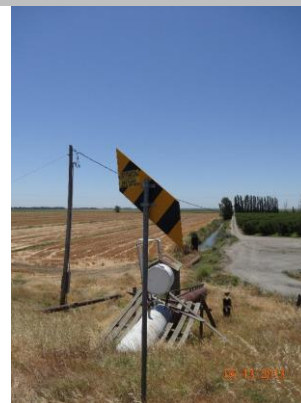
Photo 2 of 3 : UCIP_SP_2018_42118_72901.jpg

Marker visible on landward side.

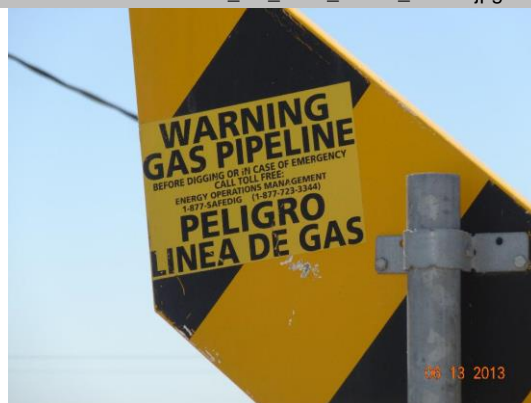
Photo 3 of 3 : UCIP_SP_2018_42118_72900.jpg

LM Start	6.40	Rating **	M	Issue No.	60 (cont)	
LM End	6.40	Issue Type +	En	Location *		
Category	Supplemental			GPS Latitude/Longitude		
				Start		End
Item	DWR UCIP Field Study			38.290356 °		38.290356 °
				-121.627488 °		-121.627488 °
DWR ID						
Comment Code						
Inspector Comment						
FS_ID:42118						
DS_ID:24054						
EP_NO: N/A						
Repair Type: Non-Urgent						
Crossing Status: Indicator Found						
UCIP Comments: Need to determine encroachment number issued for pipe installation.						
FIELD_STRUCT_DESC: Natural gas pipeline of an unknown size or material through the levee at an angle, at an unknown depth. Markers visible on each side. [Additional Reference(s): DWR Levee Log, 2005. USACE Sacramento O&M Manual 105, April 1959, (HLM 6.9)].						
FS Date: 6/13/2013

Marker with contact information on landward side.

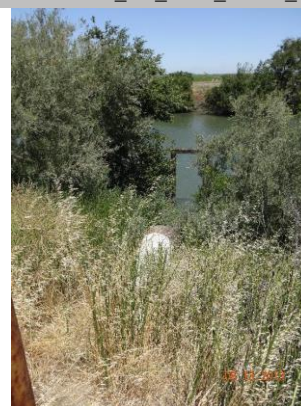
Photo 3 of 3 : UCIP_SP_2018_19668_33442.jpg

Comment Code						
Inspector Comment						
FS_ID:19668 DS_ID:21057 EP_NO: N/A Repair Type: Non-Urgent Crossing Status: Found UCIP Comments: Crossing was operating during inspection; Dense vegetation limits the inspector's visibility to identify signs of pipe failure (leaks) along the waterward slope. Recommend removing vegetation along pipe alignment to conduct proper inspection of structure and appurtenances. FIELD_STRUCT_DESC: 1 of 2: 30-inch coated steel irrigation siphon pipe through the levee, 9.5 feet below the crown. Cutoff wall around the pipe at the center of the levee. Siphon breaker on the landside (LS) slope. Primer tanks on the LS slope. Pipe exposed on both slopes. (Plans for the installation of a 30-inch siphon pipe through the levee authorized under Permit No. 611, 1934 - Reclamation District No. 501 [RD0501]. Plans to replace a 30-inch siphon pipe through the levee authorized under Permit No. 2497, 1957 - RD0501). [Additional Reference(s): DWR Levee Log, 2005. USACE Sacramento O&M Manual 105, April 1959, (HLM 6.9)]. FS Date: 6/13/2013

Pipe visible through dense vegetation. Reminiscence of platform located on river.

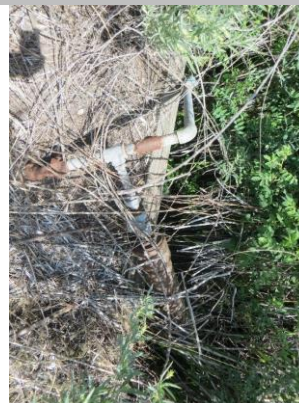
Photo 1 of 2 : UCIP_SP_2018_44748_73948.jpg

LM Start	6.41	Rating **	M	Issue No.	63
LM End	6.41	Issue Type +	En	Location *	
Category	Supplemental			GPS Latitude/Longitude	
				Start	End
Item	DWR UCIP Field Study			38.290356 °	38.290356 °
				-121.627349 °	-121.627349 °
DWR ID					
Comment Code					
Inspector Comment					
FS_ID:44748					
DS_ID:21027					
EP_NO: N/A					
Repair Type: Non-Urgent					
Crossing Status: Found					
UCIP Comments: Pipe appears abandoned and if so should be done so properly.					
FIELD_STRUCT_DESC: 2 of 2: 4-inch coated steel irrigation siphon pipe through the levee, 7.3 feet below the crown. Pipe visible on the upstream side of the wooden platform on the waterside (WS) slope.					
[Additional Reference(s): DWR Levee Log, 2005. USACE Sacramento O&M Manual 105, April 1959, (HLM 6.9)].					
FS Date: 4/23/2015

4-inch pipe connected to smaller galvanized iron pipe on WS slope.

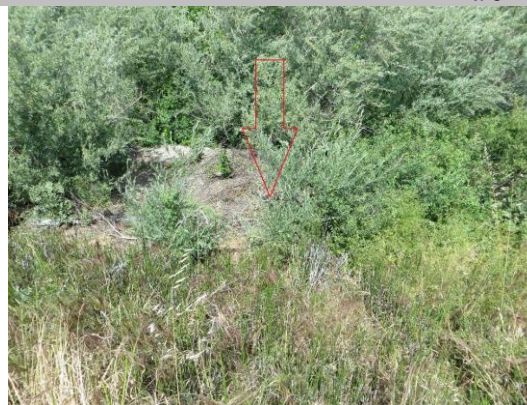
Photo 2 of 2 : UCIP_SP_2018_44748_73947.jpg

Pipe visible on upstream side of wooden platform on the WS slope.

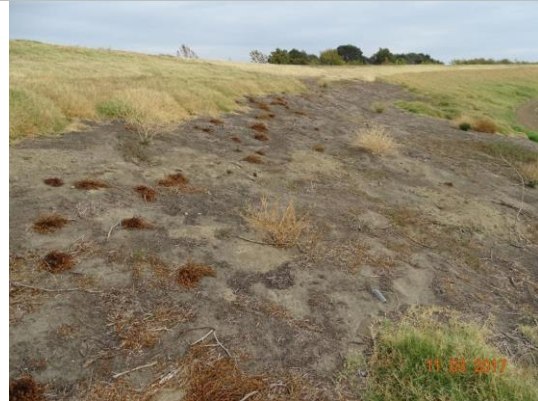
Photo 1 of 1 : SP_2018_RD0501_171_39_20180305_00007.jpg

LM Start	6.61	Rating **	M	Issue No.	39
LM End	6.61	Issue Type +	Ma	Location *	LS
Category	Earthen Levee			GPS Latitude/Longitude	
				Start	End
Item	Animal Control			38.290313 °	38.290313 °
				-121.623785 °	-121.623785 °
DWR ID	DWR_RD0501_03_f_2016_39				
Comment Code					
A1 : Exterminate rodents and backfill and compact or grout burrows.					
Inspector Comment					
Evidence of significant rodent activity at this location. Exterminate the rodents and backfill holes.

Evidence of significant rodent activity at this location. Exterminate the rodents and backfill holes.

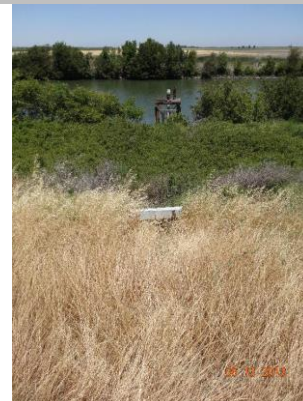
Photo 1 of 3 : UCIP_SP_2018_32544_59034.jpg

Comment Code					
Inspector Comment					
FS_ID:32544 DS_ID:21060 EP_NO: N/A Repair Type: Non-Urgent Crossing Status: Found UCIP Comments: Dense vegetation limits the inspector's visibility to identify signs of pipe failure (leaks) along the slope. Recommend removing vegetation along pipe alignment to conduct proper inspection of structure and appurtenances. Walkway missing but platform remain on the waterward side. FIELD_STRUCT_DESC: 12-inch irrigation discharge pipe of an unknown material through the levee, 6.5 feet below the crown. Switch panel on the waterside (WS) slope. Pump on a pile structure in the stream. [Additional Reference(s): DWR Levee Log, 2005. USACE Sacramento O&M Manual 105, April 1959, (HLM 7.3)]. FS Date: 6/13/2013

View of waterward side. Support piles, conduit line, and pump visible on waterward side. Dense vegetation covers waterward slope.

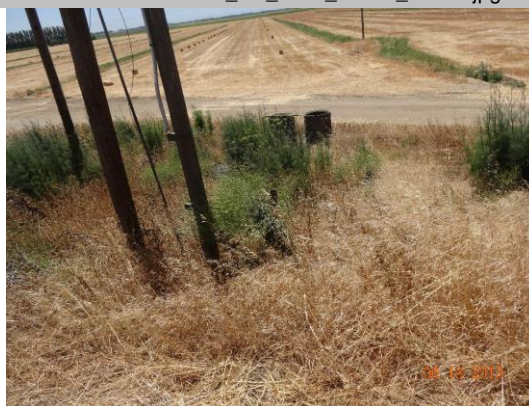
Photo 2 of 3 : UCIP_SP_2018_32544_59033.jpg

Comment Code						
Inspector Comment						
FS_ID:32544 DS_ID:21060 EP_NO: N/A Repair Type: Non-Urgent Crossing Status: Found UCIP Comments: Dense vegetation limits the inspector's visibility to identify signs of pipe failure (leaks) along the slope. Recommend removing vegetation along pipe alignment to conduct proper inspection of structure and appurtenances. Walkway missing but platform remain on the waterward side. FIELD_STRUCT_DESC: 12-inch irrigation discharge pipe of an unknown material through the levee, 6.5 feet below the crown. Switch panel on the waterside (WS) slope. Pump on a pile structure in the stream. [Additional Reference(s): DWR Levee Log, 2005. USACE Sacramento O&M Manual 105, April 1959, (HLM 7.3)]. FS Date: 6/13/2013

View of standpipes located on landward side.

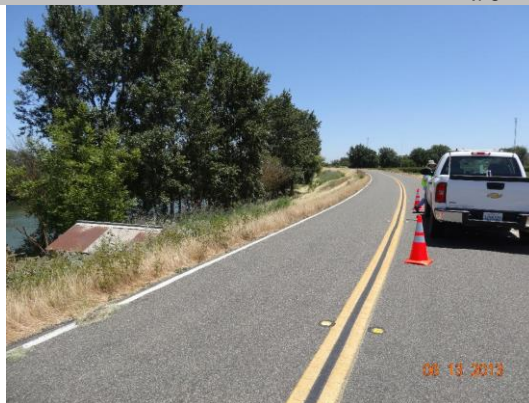
Photo 1 of 3 : UCIP_SP_2018_46834_33471.jpg

UCIP Comments: 11/19/2015 DWR Inspector (H. Phillips) coordinated with LMA superintendent and the owner for this crossing is Walter Koeing, APN No. 042220040. According to LMA superintendent owner installed filter system with fence on landward side and fence around pump in 2012. Pipe not replaced in 2012, this pipe would be a good candidate for internal inspection since the installation date for this crossing was recorded as 1946.06/13/2013 Conduit visible on landward side; new gate on WS toe; filtration system with security fence; Pipe has been upgraded--need permit authorizing work and owner. Dense vegetation limits the inspector's visibility to identify signs of pipe failure (leaks) along the waterward slope. Recommend removing vegetation along pipe alignment to conduct proper inspection of structure and appurtenances.

Overview of levee crown.

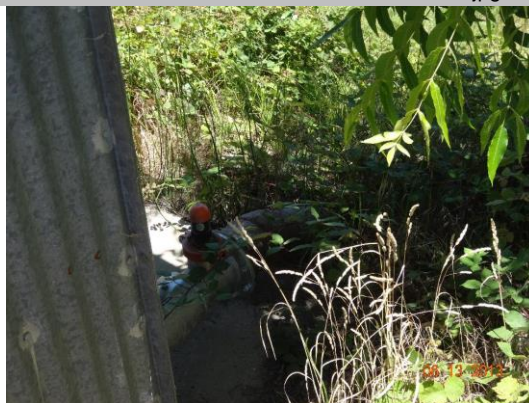
Photo 2 of 3 : UCIP_SP_2018_46834_33468.jpg

Pipe connection after pump station.

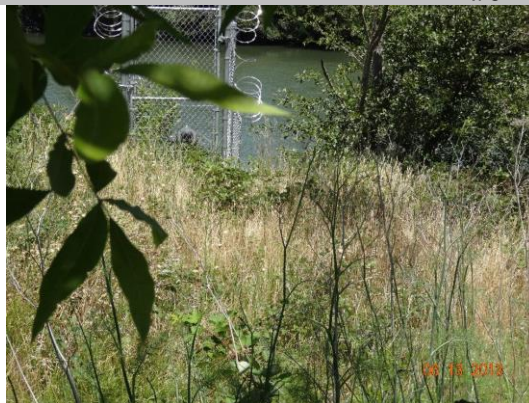
Photo 3 of 3 : UCIP_SP_2018_46834_33467.jpg

Comment Code						
Inspector Comment						
FS_ID:46834 DS_ID:21061 EP_NO: N/A Repair Type: Non-Urgent Crossing Status: Found UCIP Comments: 11/19/2015 DWR Inspector (H. Phillips) coordinated with LMA superintendent and the owner for this crossing is Walter Koeing, APN No. 042220040. According to LMA superintendent owner installed filter system with fence on landward side and fence around pump in 2012. Pipe not replaced in 2012, this pipe would be a good candidate for internal inspection since the installation date for this crossing was recorded as 1946.06/13/2013 Conduit visible on landward side; new gate on WS toe; filtration system with security fence; Pipe has been upgraded--need permit authorizing work and owner. Dense vegetation limits the inspector's visibility to identify signs of pipe failure (leaks) along the waterward slope. Recommend removing vegetation along pipe alignment to conduct proper inspection of structure and appurtenances. FIELD_STRUCT_DESC: 8-inch steel irrigation discharge pipe through the levee, 3.7 feet below the crown. Siphon breaker and service pole on the landside (LS) slope. 2-inch electrical conduit of an unknown material runs parallel to the 8-inch steel pipe. Pump in a pump house on the waterside (WS) slope. [Additional Reference(s): DWR Levee Log, 2005. USACE Sacramento O&M Manual 105, April 1959, (HLM 8.0)]. FS Date: 6/13/2013

Pipe section near toe is protected by security fence.

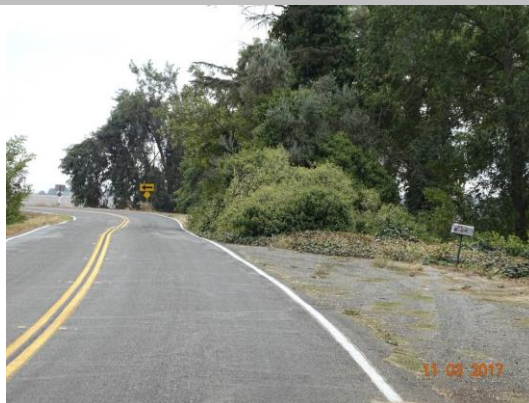
Photo 1 of 1 : SP_2018_RD0501_171_42_20180305_00010.jpg

LM Start	7.55	Rating **	U	Issue No.	42
LM End	7.55	Issue Type +	En	Location *	LS
Category	Earthen Levee			GPS Latitude/Longitude	
				Start	End
Item	Vegetation			38.286653 °	38.286653 °
				-121.608417 °	-121.608417 °
DWR ID	DWR_RD0501_03_f_2017_42				
Comment Code					
V6 : Landscaping					
Inspector Comment					
Remove/thin landscaping to allow inspection and access to landside slope and toe.

Remove/thin landscaping to allow inspection and access to landside slope and toe.

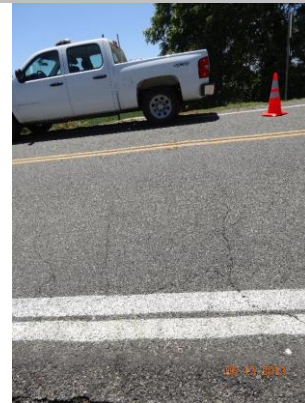
Photo 1 of 3 : UCIP_SP_2018_50025_59039.jpg

Comment Code						
Inspector Comment						
FS_ID:50025 DS_ID:21063 EP_NO: 11812 Repair Type: Non-Urgent Crossing Status: Found UCIP Comments: 8/22/2016 Crossing has been downgraded from Urgent to Non-Urgent no levee damage appears to be present along pipe alignment. There appears to be an erosion site adjacent to this crossing. Need to coordinate with DWR Inspectors. (DWR UCIP - omagana)6/07/2013 Open cut section of levee on LS slope 8 foot wide--repair work needed. Abandoned pump on waterward berm. Dense vegetation--Recommend removing vegetation along pipe alignment to conduct proper inspection of structure and appurtenances on waterward side. (DWR UCIP - omagana) FIELD_STRUCT_DESC: 14-inch coated steel irrigation discharge pipe and a 1.25-inch electrical conduit of an unknown material through the levee, both 3 feet below the crown. Cutoff wall around the pipe and conduit at the center of the levee. Siphon breaker at the apex of the pipe on the landside (LS) shoulder. Slant pump on the waterside (WS) slope. Discharge structure at the LS toe. Rock revetment on the WS slope. (Plans to replace a 14-inch irrigation pipe through the levee crown and a slant pump on the riverbank authorized under Permit No. 11812, 1976 - Harry H. Rasmussen). [Additional Reference(s): DWR Levee Log, 2005]. FS Date: 8/22/2016

View of levee crown at crossing.

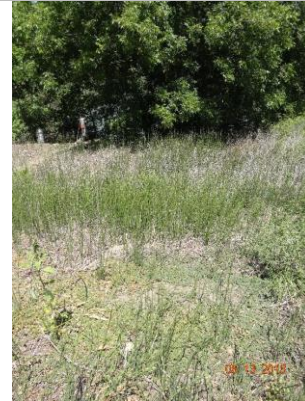
Photo 2 of 3 : UCIP_SP_2018_50025_59042.jpg

Comment Code						
Inspector Comment						
FS_ID:50025 DS_ID:21063 EP_NO: 11812 Repair Type: Non-Urgent Crossing Status: Found UCIP Comments: 8/22/2016 Crossing has been downgraded from Urgent to Non-Urgent no levee damage appears to be present along pipe alignment. There appears to be an erosion site adjacent to this crossing. Need to coordinate with DWR Inspectors. (DWR UCIP - omagana)6/07/2013 Open cut section of levee on LS slope 8 foot wide--repair work needed. Abandoned pump on waterward berm. Dense vegetation--Recommend removing vegetation along pipe alignment to conduct proper inspection of structure and appurtenances on waterward side. (DWR UCIP - omagana) FIELD_STRUCT_DESC: 14-inch coated steel irrigation discharge pipe and a 1.25-inch electrical conduit of an unknown material through the levee, both 3 feet below the crown. Cutoff wall around the pipe and conduit at the center of the levee. Siphon breaker at the apex of the pipe on the landside (LS) shoulder. Slant pump on the waterside (WS) slope. Discharge structure at the LS toe. Rock revetment on the WS slope. (Plans to replace a 14-inch irrigation pipe through the levee crown and a slant pump on the riverbank authorized under Permit No. 11812, 1976 - Harry H. Rasmussen). [Additional Reference(s): DWR Levee Log, 2005]. FS Date: 8/22/2016

View of WS--pump located at the berm edge.

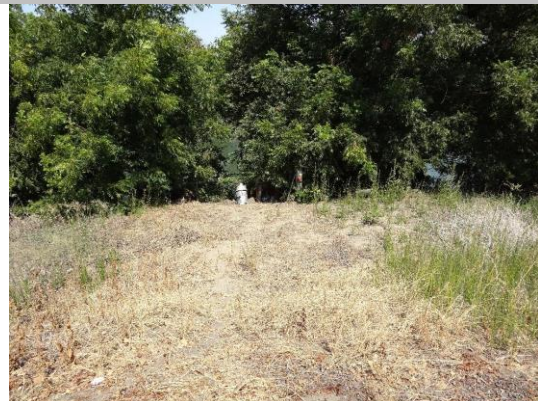
Photo 3 of 3 : UCIP_SP_2018_50025_75668.jpg

View of WS.

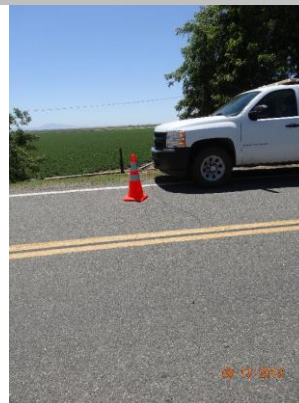
Photo 1 of 3 : UCIP_SP_2018_32546_59047.jpg

Comment Code						
Inspector Comment						
FS_ID:32546						
DS_ID:21064						
EP_NO: N/A						
Repair Type: Non-Urgent						
Crossing Status: Found						
UCIP Comments: Debris (pipe section) located on waterward berm.						
Dense vegetation limits the inspector's visibility to identify signs of pipe						
failure (leaks) along the waterward slope. Recommend removing						
vegetation along pipe alignment to conduct proper inspection of						
structure and appurtenances.						
FIELD_STRUCT_DESC: 8-inch steel irrigation discharge pipe through						
the levee, 2.7 feet below the crown. Pump in a pump house at the						
landside (LS) toe. [Additional Reference(s): DWR Levee Log, 2005.						
USACE Sacramento O&M Manual 105, April 1959, (HLM 8.2)].						
FS Date: 6/13/2013

View of levee crown at crossing.

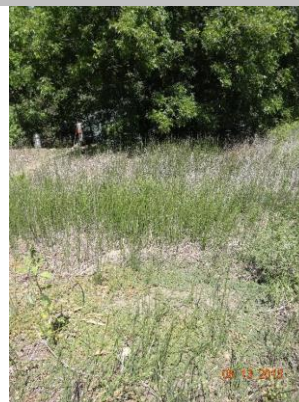
Photo 2 of 3 : UCIP_SP_2018_32546_59048.jpg

View of waterward side--dense vegetation limits visibility of 8-inch steel pipe. Pump belongs to another crossing.

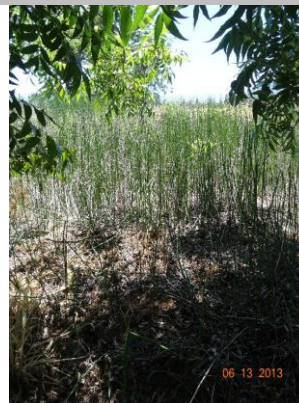
Photo 3 of 3 : UCIP_SP_2018_32546_59049.jpg

Comment Code						
Inspector Comment						
FS_ID:32546						
DS_ID:21064						
EP_NO: N/A						
Repair Type: Non-Urgent						
Crossing Status: Found						
UCIP Comments: Debris (pipe section) located on waterward berm.						
Dense vegetation limits the inspector's visibility to identify signs of pipe						
failure (leaks) along the waterward slope. Recommend removing						
vegetation along pipe alignment to conduct proper inspection of						
structure and appurtenances.						
FIELD_STRUCT_DESC: 8-inch steel irrigation discharge pipe through						
the levee, 2.7 feet below the crown. Pump in a pump house at the						
landside (LS) toe. [Additional Reference(s): DWR Levee Log, 2005.						
USACE Sacramento O&M Manual 105, April 1959, (HLM 8.2)].						
FS Date: 6/13/2013

View of waterward side looking up at levee shoulder.

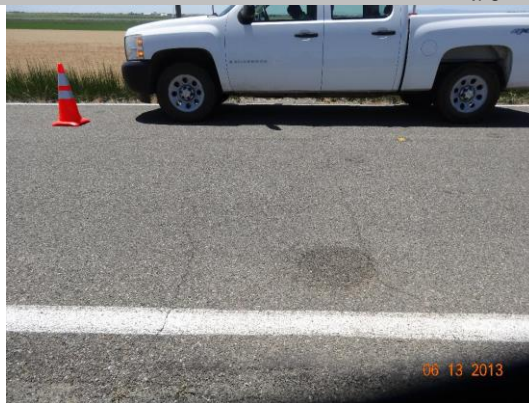
Photo 1 of 3 : UCIP_SP_2018_32547_59050.jpg

Item	DWR UCIP Field Study		38.278848 °	38.278848 °								
			-121.601216 °	-121.601216 °								
DWR ID												
Comment Code												
Inspector Comment												
FS_ID:32547 DS_ID:21080 EP_NO: 18135 Repair Type: Non-Urgent Crossing Status: Found UCIP Comments: Cracks visible on levee crown could be associated with pipe vibration or settlement. Burrow activity on landward side. Recommend removing vegetation along pipe alignment on landward side to conduct proper inspection of structure and appurtenances. FIELD_STRUCT_DESC: 10-inch galvanized iron irrigation discharge pipe through the levee, 3.5 feet below the crown. Cutoff wall around the pipe on the landside (LS) shoulder. Slant pump and pump house on the waterside (WS) slope. Concrete standpipe and power pole at the LS toe. Service pole on the LS slope. Pipe exposed on both slopes. Two crossings are nearby: A 10-inch pipe and an 8-inch pipe crossings are approximately 5 feet apart. (Plans to replace an existing pump and pipeline with a new pump and pipeline authorized under Permit No. 2446, 1957 - Doris R. Geary. Plans to replace an existing water pipe with a 10-inch steel pipe through the levee authorized under Permit No. 18135, 2006 - Charlotte Gilmore). [Additional Reference(s): DWR Levee Log, 2005]. FS Date: 6/7/2013

View of levee crown.

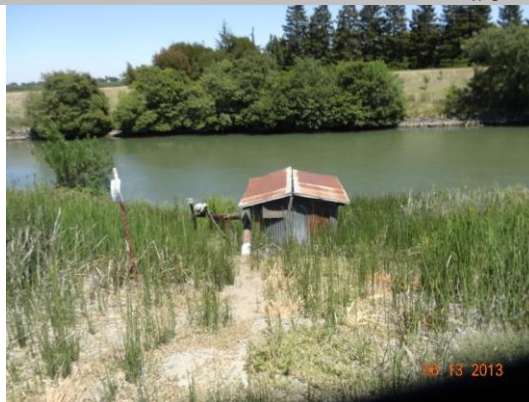
Photo 2 of 3 : UCIP_SP_2018_32547_59051.jpg

Overview of waterward side--2 crossings located within 5 feet.

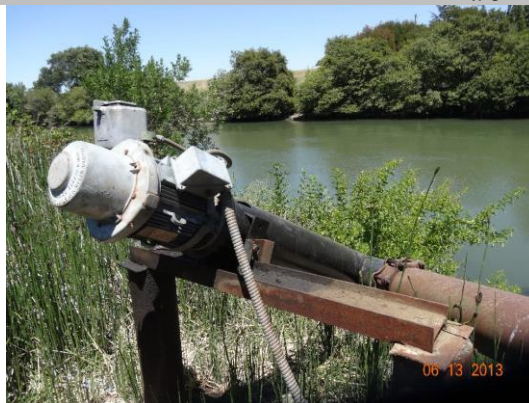
Photo 3 of 3 : UCIP_SP_2018_32547_59053.jpg

Comment Code						
Inspector Comment						
FS_ID:32547 DS_ID:21080 EP_NO: 18135 Repair Type: Non-Urgent Crossing Status: Found UCIP Comments: Cracks visible on levee crown could be associated with pipe vibration or settlement. Burrow activity on landward side. Recommend removing vegetation along pipe alignment on landward side to conduct proper inspection of structure and appurtenances. FIELD_STRUCT_DESC: 10-inch galvanized iron irrigation discharge pipe through the levee, 3.5 feet below the crown. Cutoff wall around the pipe on the landside (LS) shoulder. Slant pump and pump house on the waterside (WS) slope. Concrete standpipe and power pole at the LS toe. Service pole on the LS slope. Pipe exposed on both slopes. Two crossings are nearby: A 10-inch pipe and an 8-inch pipe crossings are approximately 5 feet apart. (Plans to replace an existing pump and pipeline with a new pump and pipeline authorized under Permit No. 2446, 1957 - Doris R. Geary. Plans to replace an existing water pipe with a 10-inch steel pipe through the levee authorized under Permit No. 18135, 2006 - Charlotte Gilmore). [Additional Reference(s): DWR Levee Log, 2005]. FS Date: 6/7/2013

Slant pump located on waterward side. 10 inch pipe connects at an angle to tar coated pipe.
